September 25, 2015

Subject: Condition Inspection of Piseco Lake Outlet Dam

The Piseco Lake Outlet Dam (State ID: 156-0615, Federal ID: NY01186) is located at the outlet of Piseco Lake, on Piseco Outlet Stream, a tributary to the West Branch Sacandaga River, in the Town of Arietta, Hamilton County, New York. The dam is situated about 100 feet downstream of the NYS Route 10 and is shown in the NYSDOT bridge replacement design drawings dated October 18, 1966. According to the New York State Inventory of Dams, the original dam was built in 1888 and has Class A low hazard classification. The NYS dam inventory data sheet, dam location map and NYSDOT design drawing are included in Attachment A to this letter. The owner of the dam is a private entity. The Town of Arietta (Town) operates the dam flashboards to control the lake level and has an easement to the site to operate and maintain the dam.

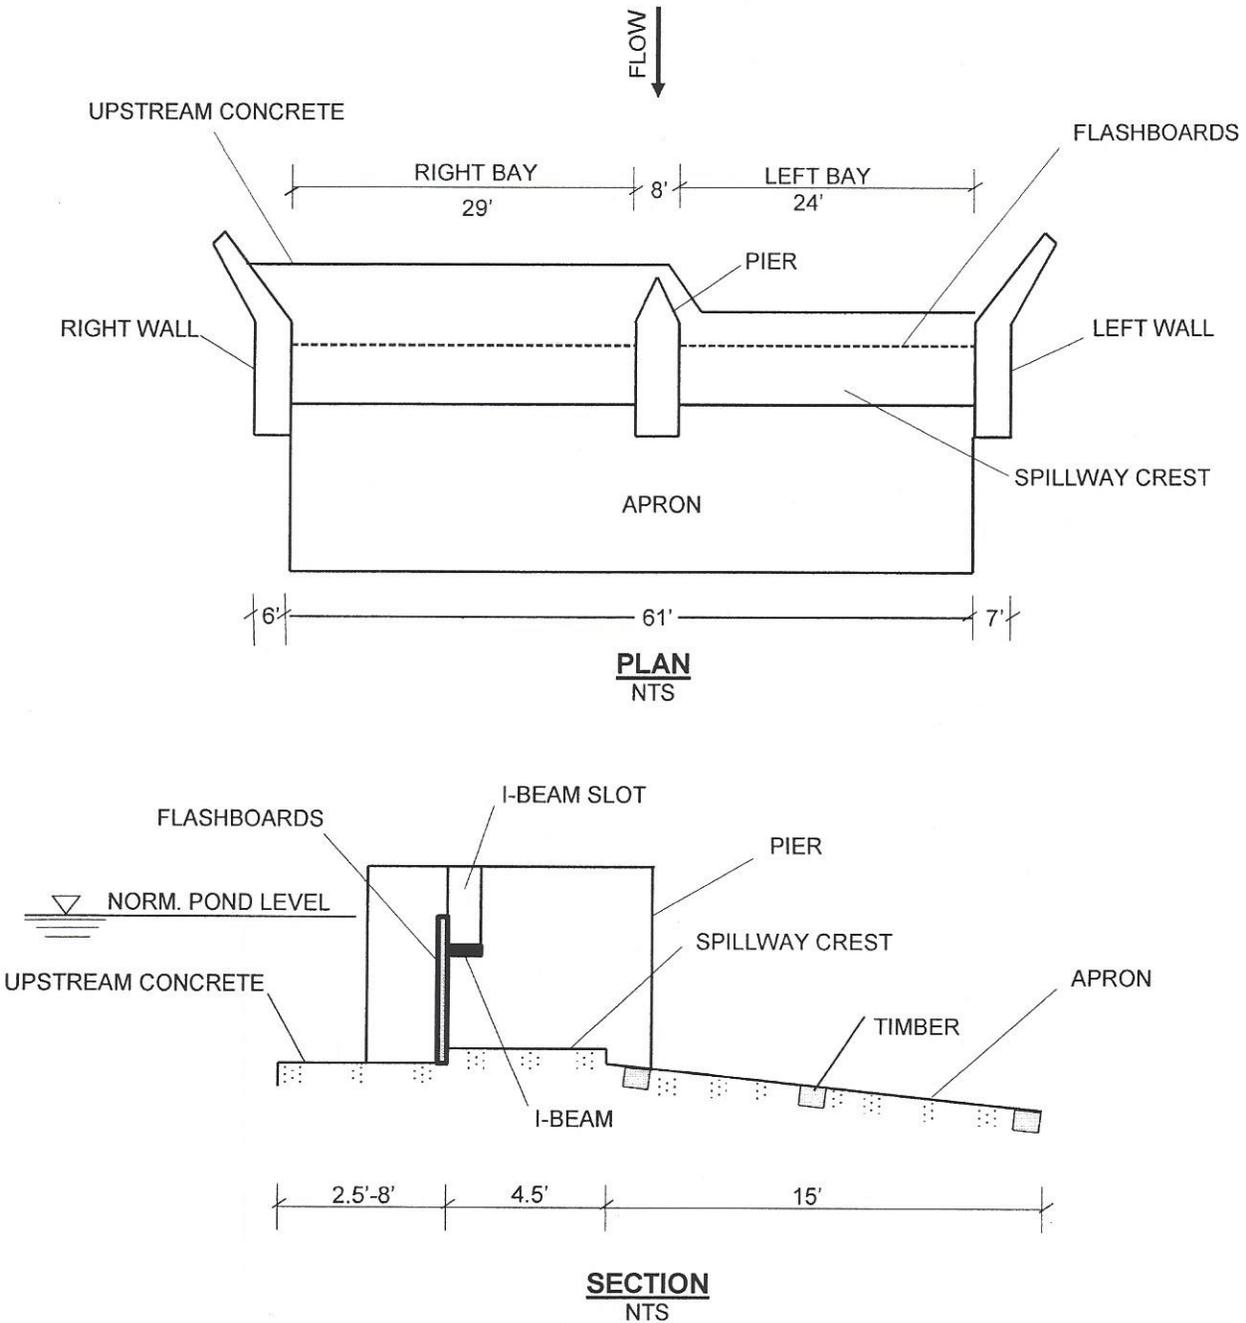
FIGURE 1. PISECO LAKE OUTLET DAM: PLAN AND SECTION

The dam is a concrete gravity structure consisting of a spillway, an apron and abutment walls. The spillway is a 4.5-foot wide broad-crested weir divided by a 8-foot thick concrete pier on two bays: a left<sup>2</sup>, 24-foot long bay and a right, 29-foot long bay. The spillway crest houses removable flashboards supported in each bay with a 2-inch high step in the concrete crest and a horizontal flanged steel I-beam elevated about 2 feet above the crest. The spillway concrete extends upstream from the flashboard line by about 8 feet in the right bay and about 2.5 feet in the left bay. The apron installed at the toe of the spillway crest is about 15 feet wide and inclines downward at an estimated slope 10H:1V (horizontal to vertical). Each abutment wall consists of two parts: about 15 feet long upstream wing section oriented at about 45 degrees to the direction of flow and downstream section, approximately 7 to 8 feet long and 6 to 7 feet thick. The height of the right wall and pier above the spillway crest is about 4 feet and the height of the left wall above the crest is about 5 feet. The wing walls are tapering upstream to a 1-foot thickness. The abutment walls and pier contain 12 by 12 inches slots to accommodate the flashboard supporting steel beams. A general arrangement of the dam, a plan and section, developed using field observations and measurements, is shown in an interpretive engineering sketch in Figure 1.
