**ATTACHMENT A**  
**PROJECT DOCUMENTATION**

Name of Dam: Piseco Lake Outlet Dam

State ID: 156-0615

**ATTACHMENT B**  
**INSPECTION PHOTOGRAPHS**

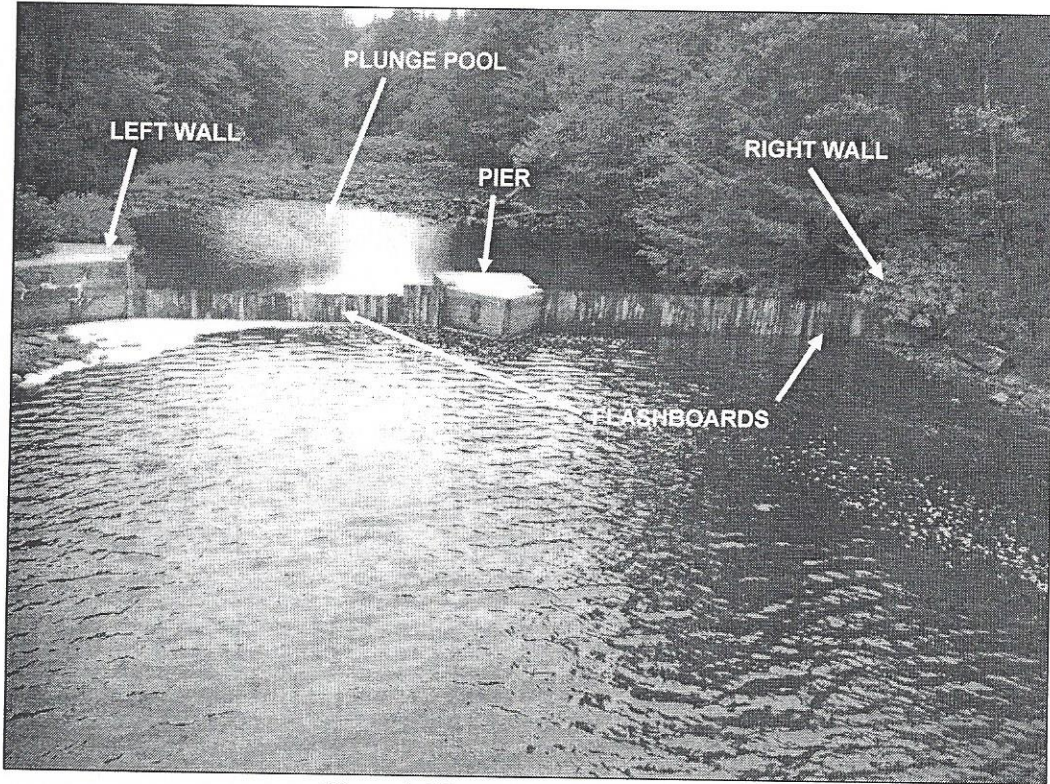
Photo 1. Upstream View of Dam.

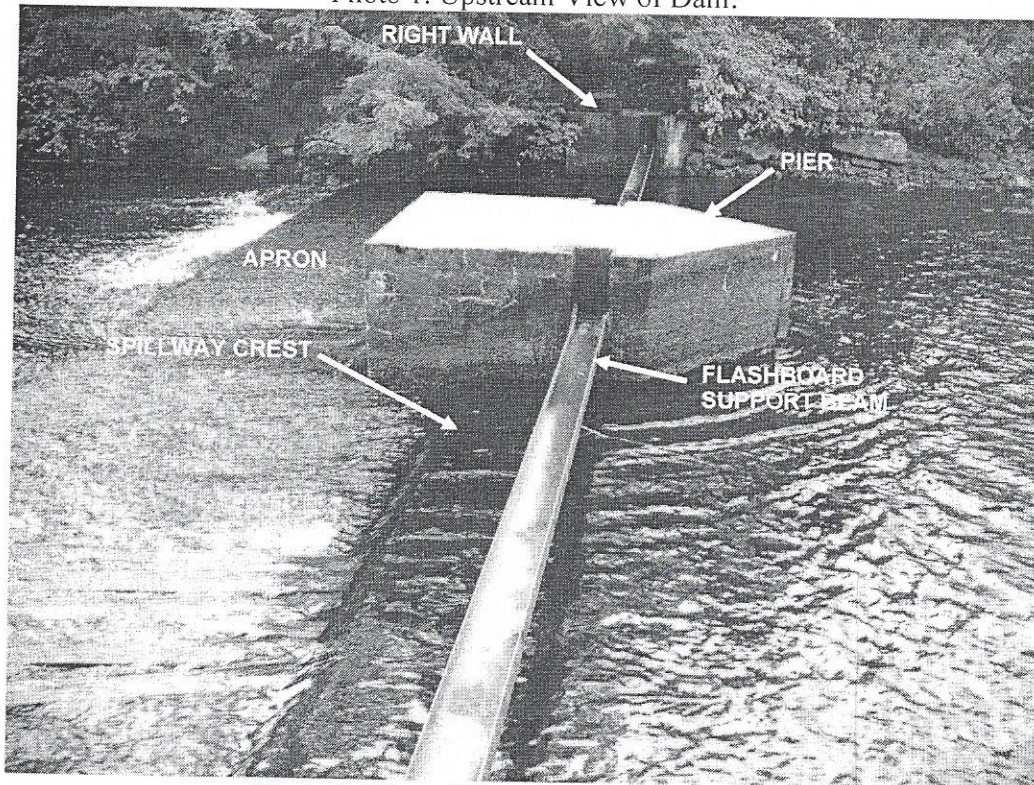
Photo 2. View of Dam from Left Abutment.

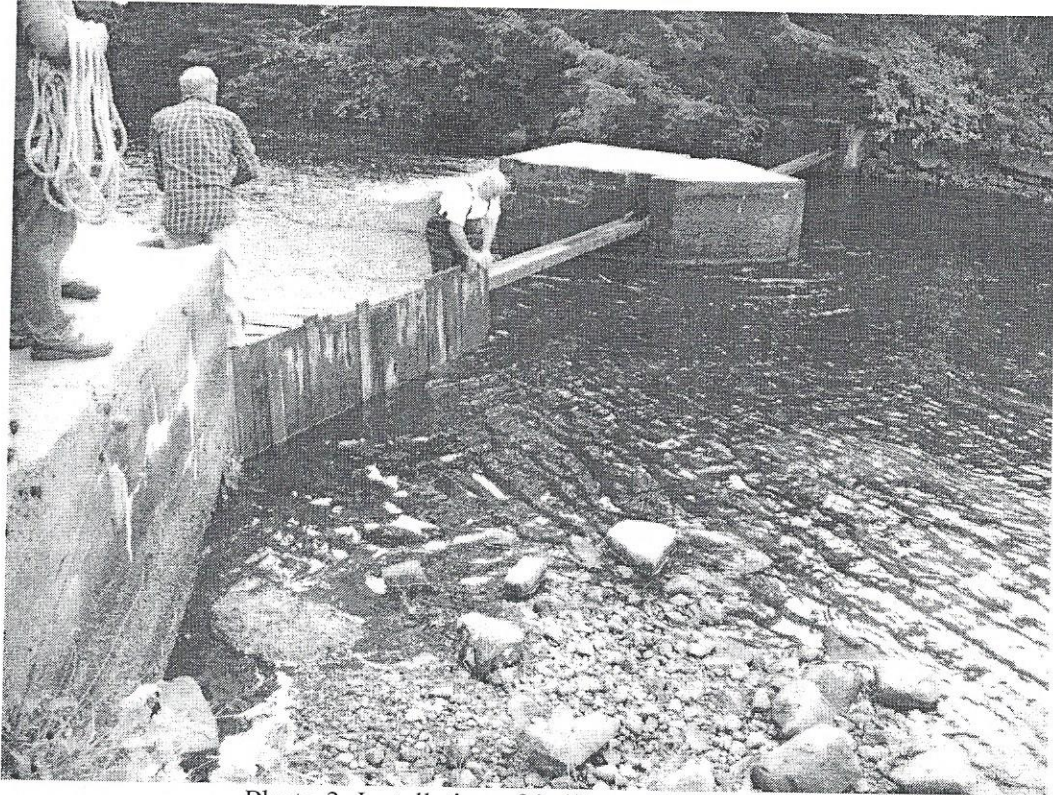
Photo 3. Installation of Spillway Flashboards.

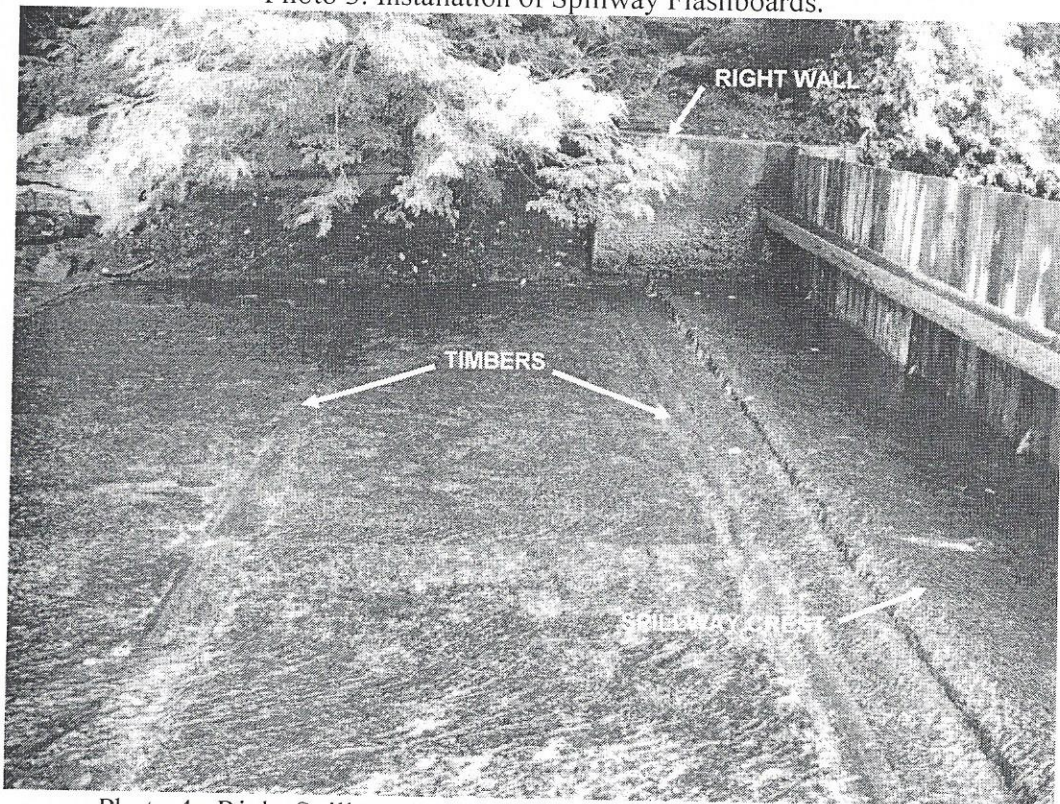
Photo 4. Right Spillway Bay Crest, Apron and Right Abutment Wall.

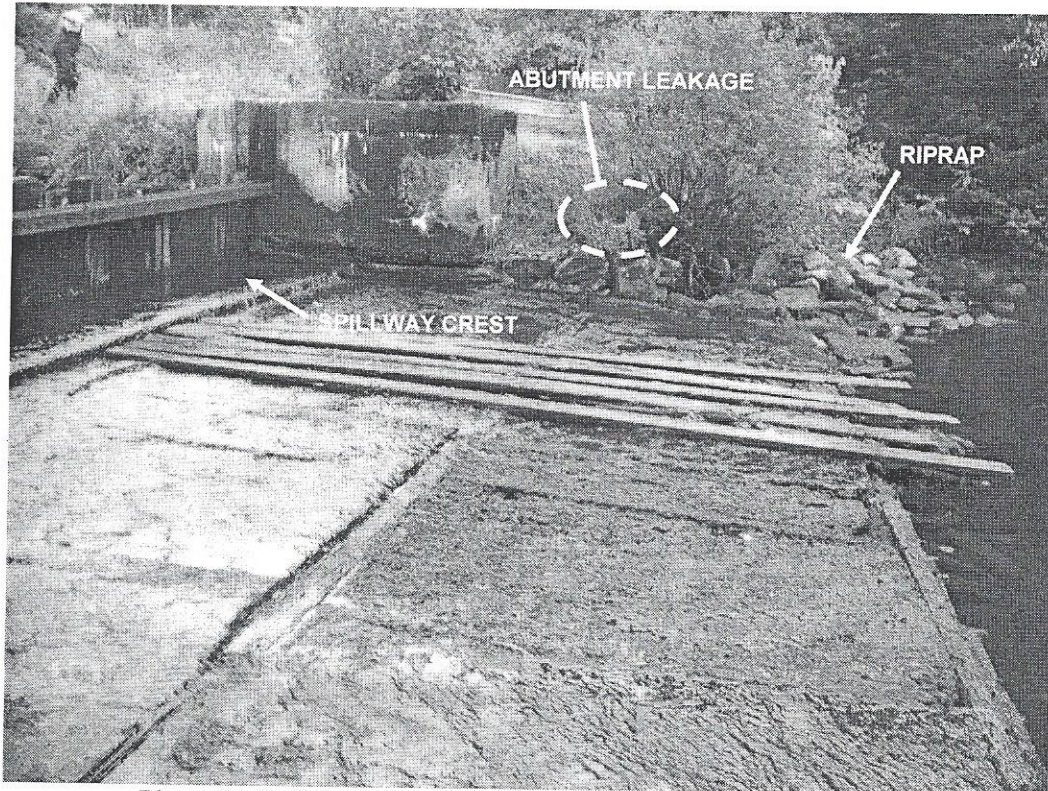
Photo 5. Left Spillway Bay: Crest, Apron and Abutment Wall.

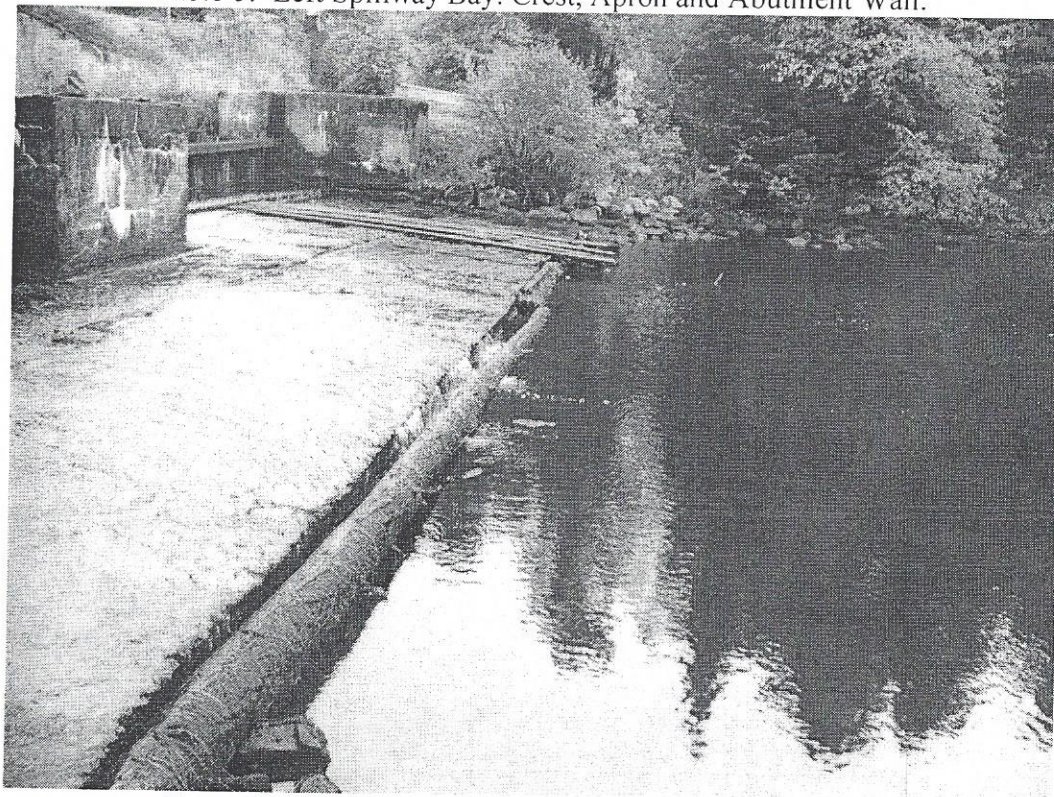
Photo 6. Separation of Protective Timber from Apron Toe.

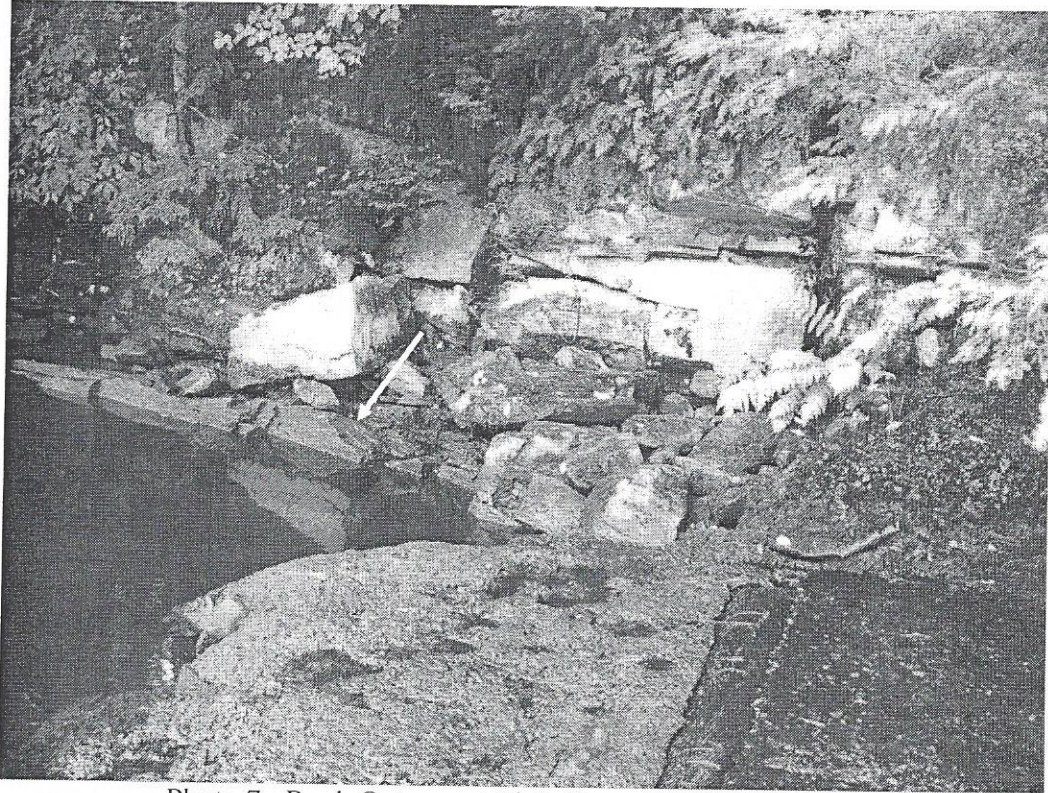
Photo 7. Rock Outcrop at Right Dam Abutment (Arrow).

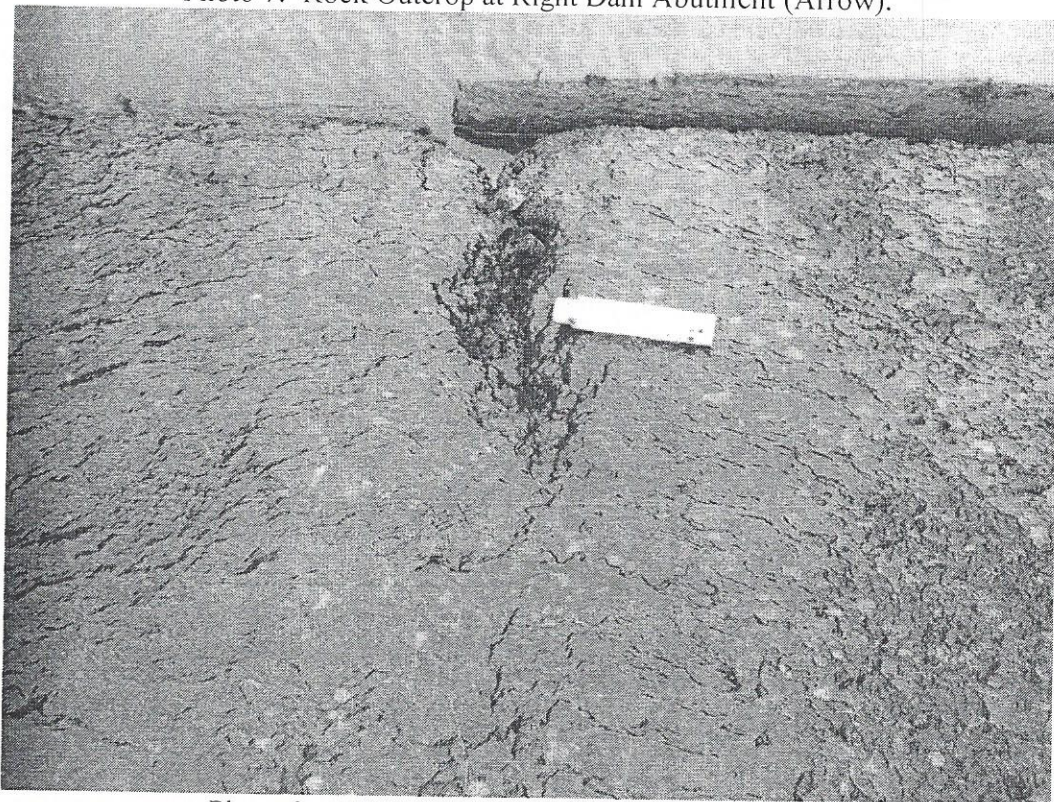
Photo 8. Apron Slab Erosion in Left Spillway Bay.

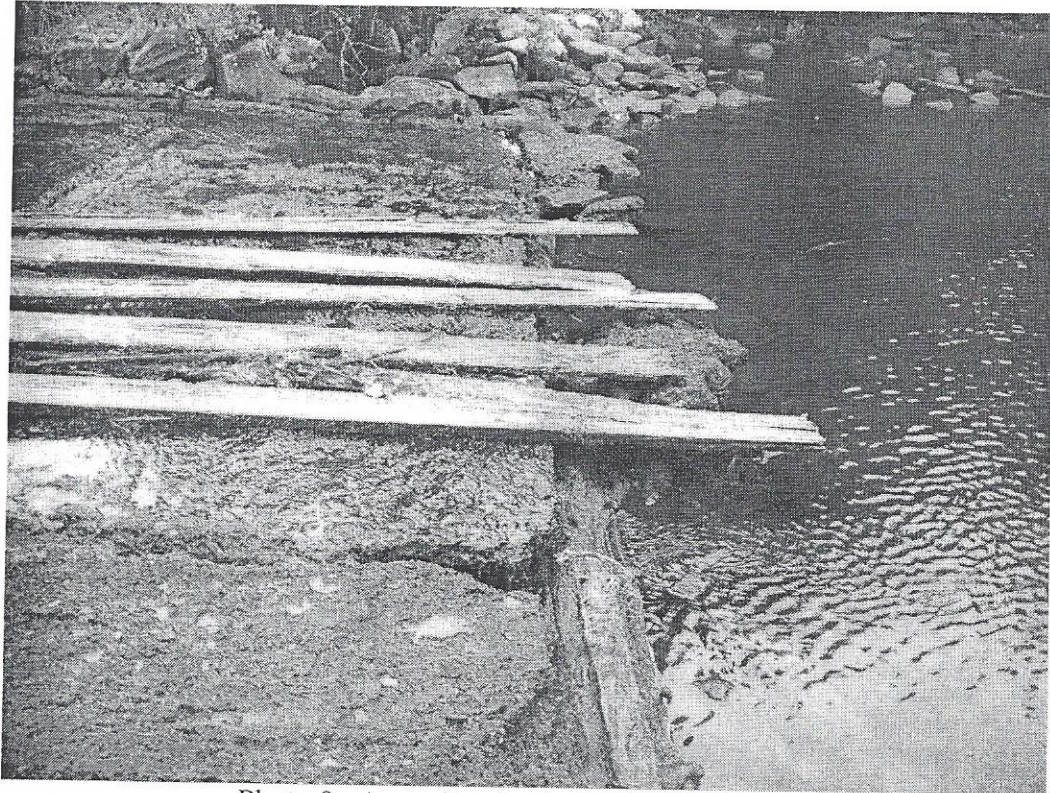
Photo 9. Apron Erosion in Left Spillway Bay.

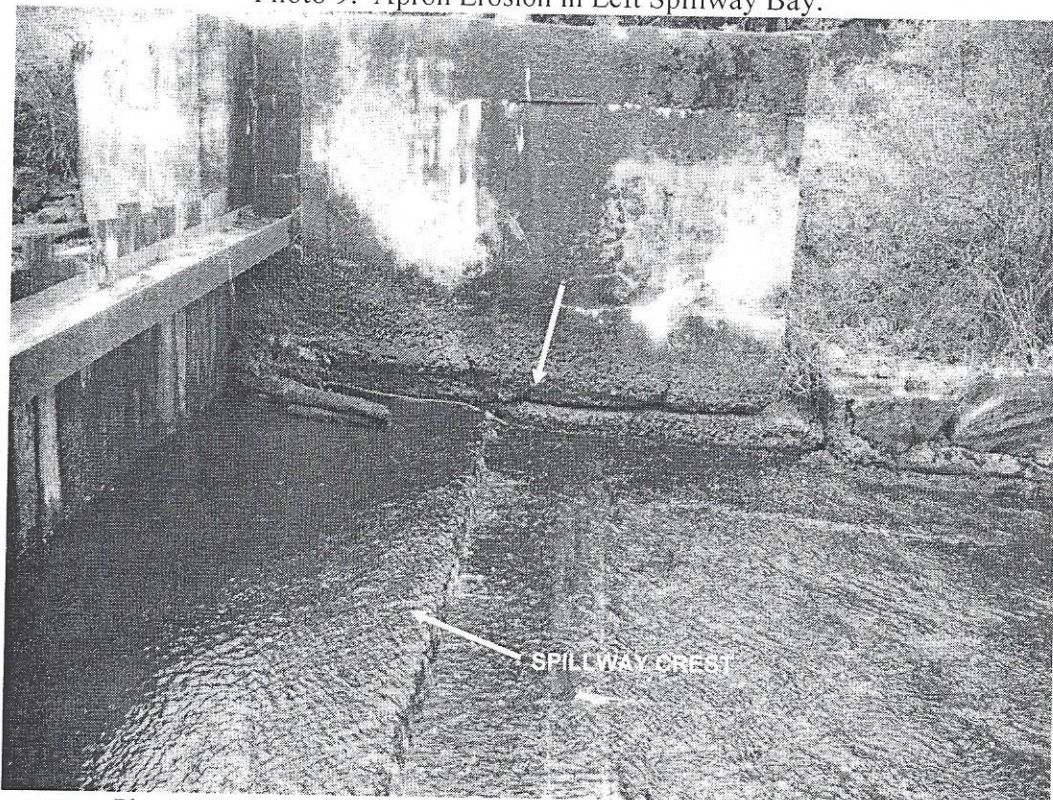
Photo 10. Left Abutment Wall Erosion and Undermining (Arrow).

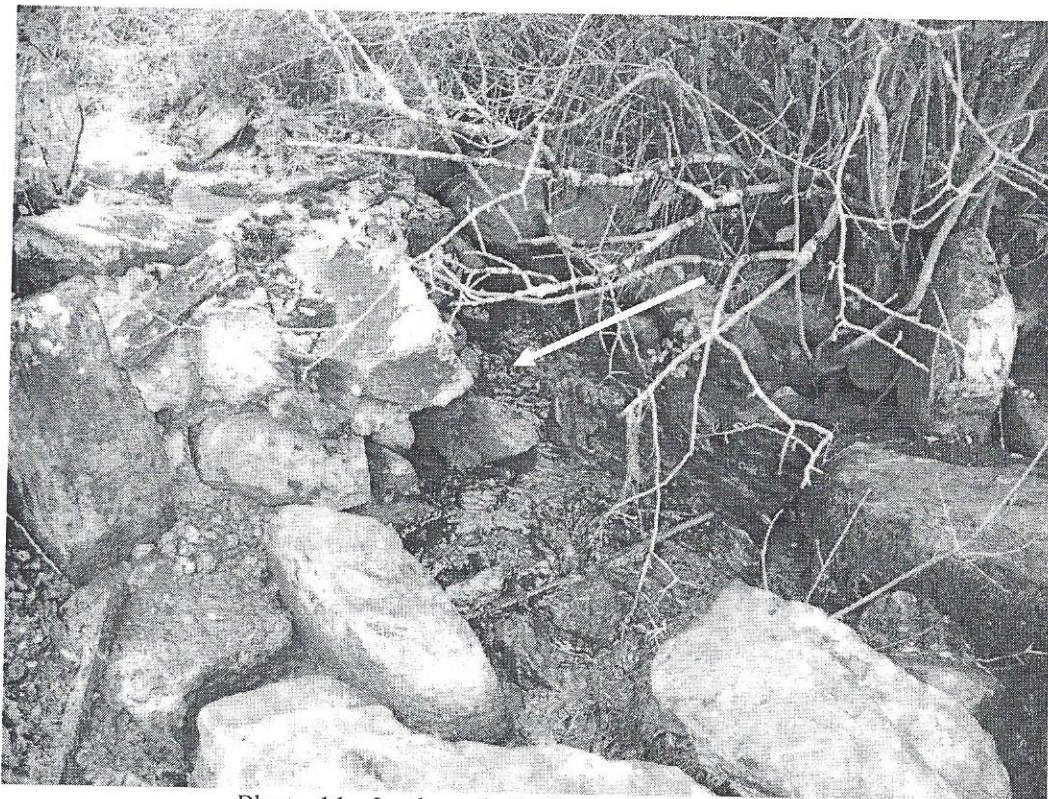
Photo 11. Leakage in Left Abutment (Arrow).

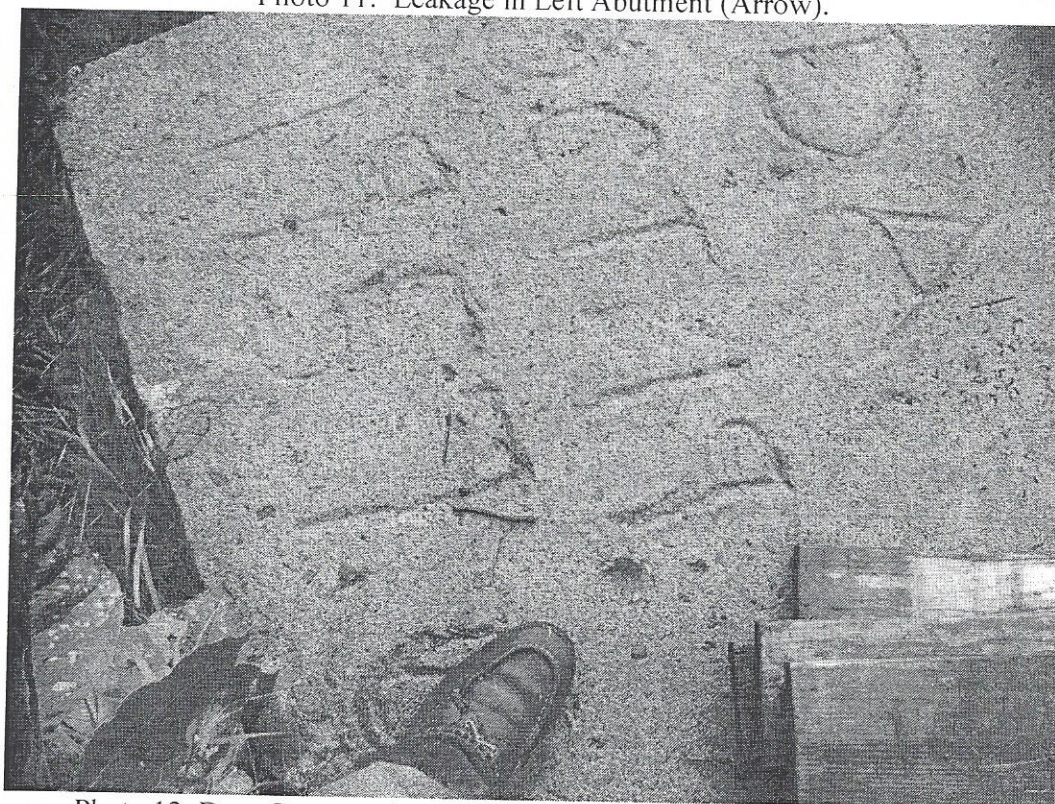
Photo 12. Dam Construction Date Imprint on Top of Left Abutment Wall.
